ENGINEER DESIGN TEST OF HOWITZER,

LIGHT, SELF-PROPELLED,

105-MM, XM104

Report No. DPS-955

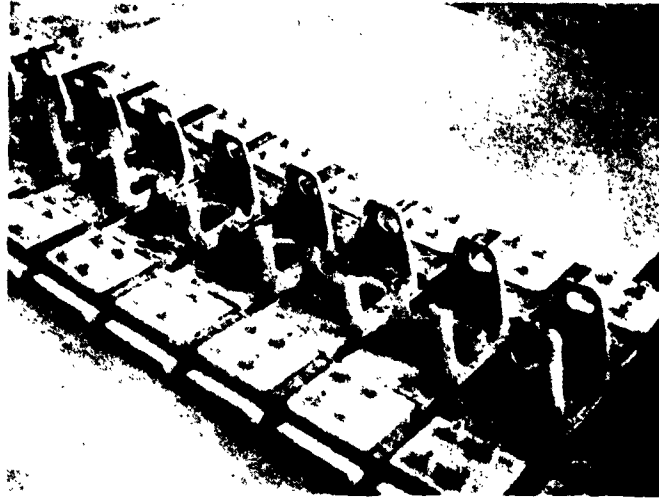
Figure 7: Failed Center Guides in Left Track.

After the rebuilt track had operated 312 miles, six center guides of the left track failed (Figure 7).

The vehicle had been operating on the level cross-country course on frozen ground and was having difficulty maneuvering between large ruts made by an M60 tank. The left tracks were on the lower side of a slope when the track came off. The No. 4 road wheel was damaged also. Replacement guides and a new road wheel were installed. The tracks completed the remainder of the test without further failures.
